**Final Environmental Assessment for  
Landfill Drainage Improvements  
Vandenberg Air Force Base, California**

**April 7, 2003**

30 CES/CEVPP  
806 13th Street, Suite 116  
Vandenberg Air Force Base, California 93437

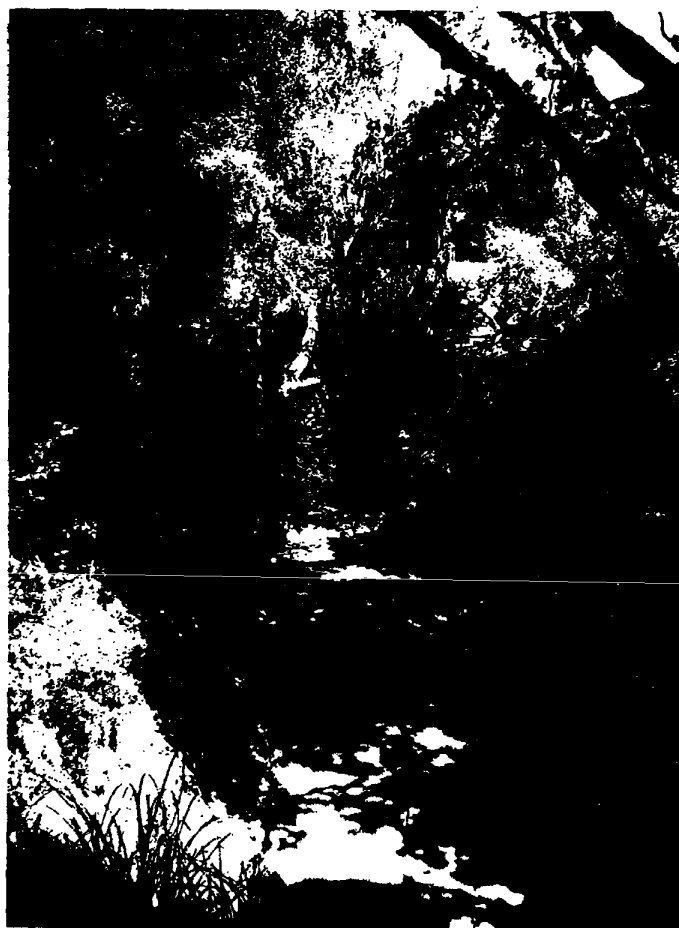
**Sampling Station SS-2  
Oak Canyon  
Waters of the United States**

Wetland surveys in Oak Canyon were carried out at two sampling stations, SS-1 and SS-2, located in riparian coast live oak woodland. Station SS-1 was established in the tributary to Oak Canyon found below the outlet of the Alternative 1 and 2 routes, and SS-2 was located just below the confluence of this tributary and the drainage leading south of the landfill. The hydrophytic vegetation criterion was not met at the two sampling stations. Wetland hydrology was indicated at both stations by the presence of a watercourse with flowing water. Inundation was observed at SS-1, and free water in the soil pit at SS-2. Hydric soils could not be confirmed at either station. The soil was too rocky to dig at SS-1, and soil colors could not be determined for the variable riverwash sand at SS-2. Both stations were determined to qualify as USACE jurisdictional waters of the United States.

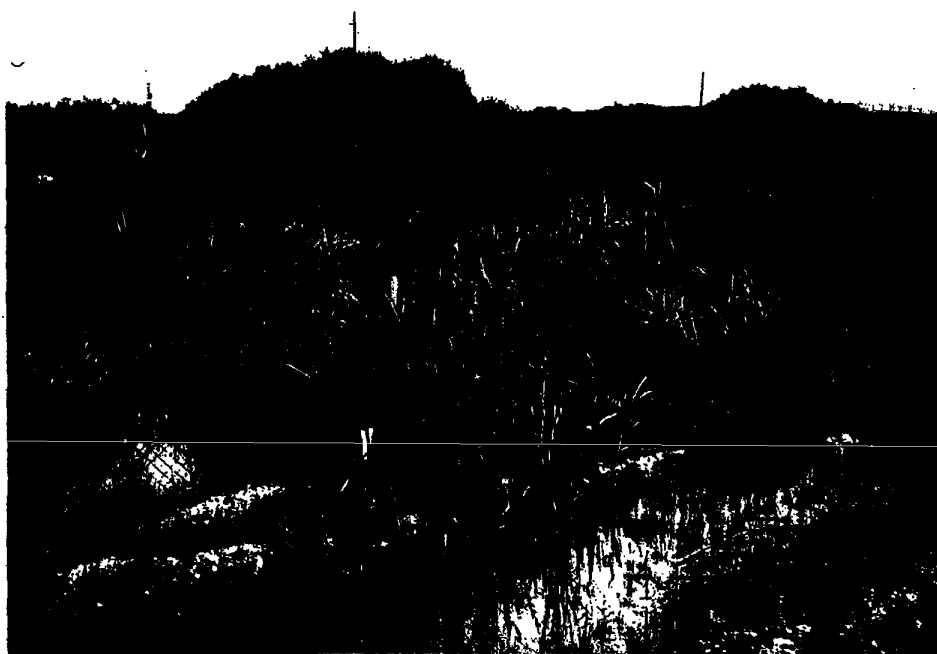
**Sampling Station SS-11, Northeast Part of Landfill, Artificially Created Wetland**

In addition to stations SS-3 and SS-10, an atypical situation also was observed at station SS-11. This station was located in a ponded area at the northeast corner of the landfill where the Alternative 1 route would run near the fence of the Subtitle D boundary. Station SS-11 had positive indicators of hydrophytic vegetation, wetland hydrology, and hydric soils, and therefore was determined to be an atypical wetland. It is atypical since the inundated area present here likely has been created artificially by surface runoff being dammed by a berm within the landfill. With implementation of the project, it is likely that the man-made hydrologic condition at this location will cease to exist due to diversion of storm water flows from the landfill. Therefore, it would not qualify as a jurisdictional wetland or "isolated wetland" protected under Section 404 of the Clean Water Act or EO 11990.
